Coal Operators' Conference

2015

Longwall Salvage Roof Fall Recovery Experience

LONGWALL SALVAGE ROOF FALL RECOVERY EXPERIENCE

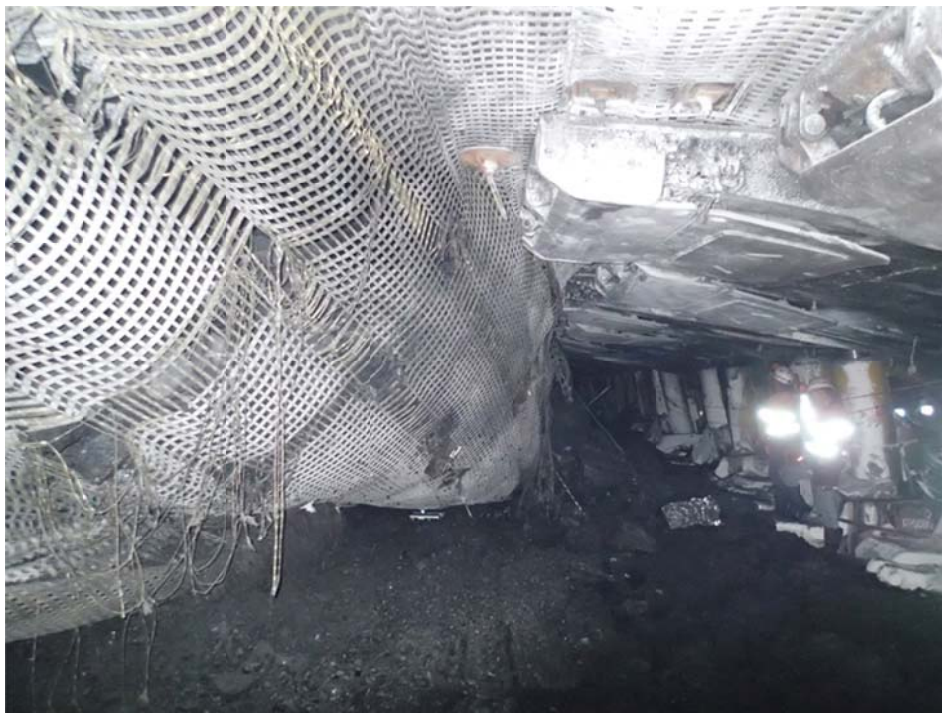
- 4th January – At 3.30am, during the salvage of shield 76, a fall of ground occurred from shield 55 to the E-frame (40 m).
 - Shield 76 under the fall
 - Shields iron bound from 75 to 64

The fall was limited from the tips of the forward shields to the face line (approx. 3 m – 4 m wide). The face line had crushed out significantly leading up to the fall. The height of the fall was estimated to be at least 8m (full length of cables visible and laser range finder used). Access and inspection of the fall was possible by traveling along the back of the remaining shields to the E-frame. Figures 4, 5 and 6 illustrate the extent of the fall.

Figure 4: Fall of ground from shield 55 looking towards the E-frame

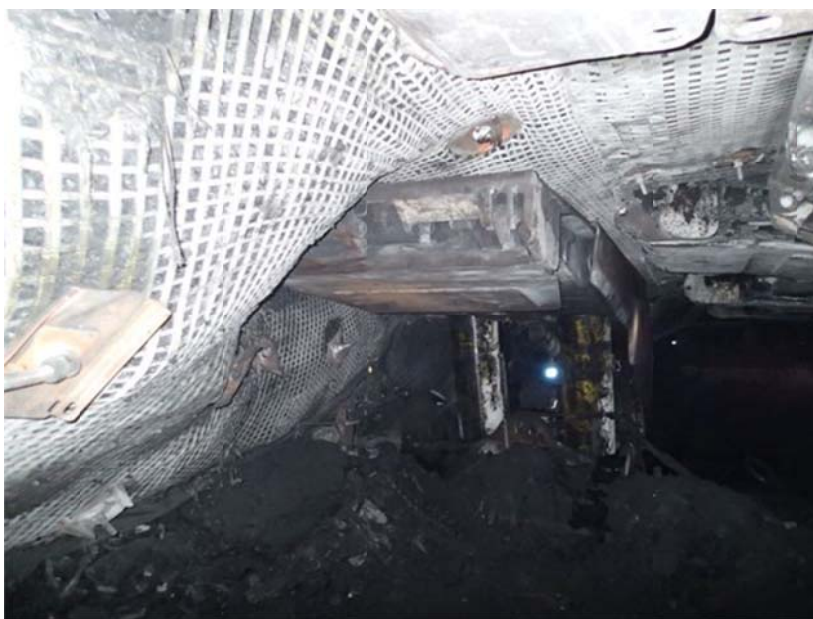
Figure 5: Shield 76 under the fall – in the middle of the face road

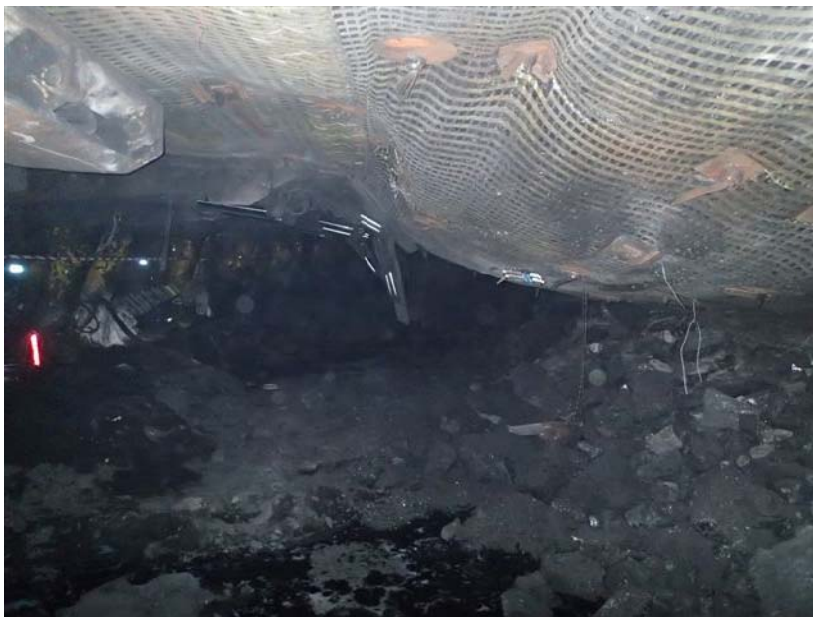
Figure 6: View from the E-frame looking towards the MG

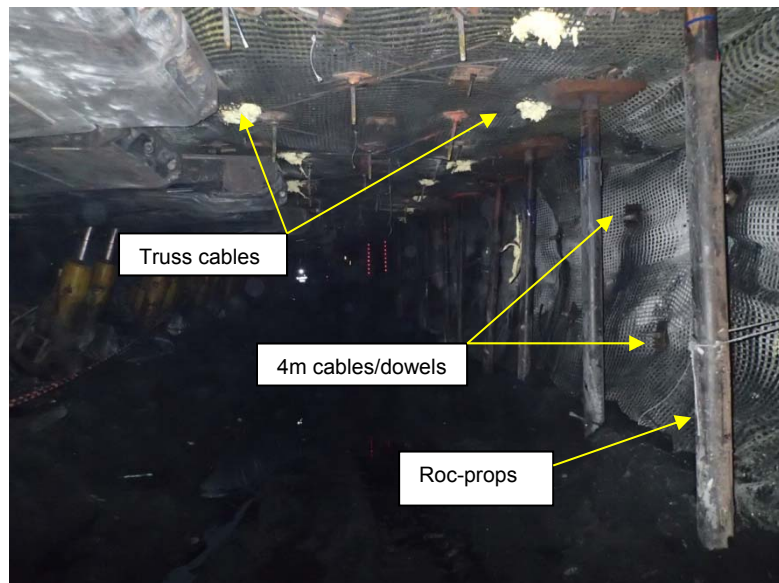
Figure 7: immediate response re-support outbye of the fall

1. Standing rock-props along the face side from shield 25 to the lip of the fall to limit any shearing vertically along the block.

2. Install cable trusses from shield 25 inbye to the fall, with the cables angled well out over the face and the shield canopies.
3. Installation of 4m cables and dowels into the face side rib and also within the MG chute road, in order to strengthen the coal block.
4. Install monitoring devices down the length of the roadway and develop an inspection regime

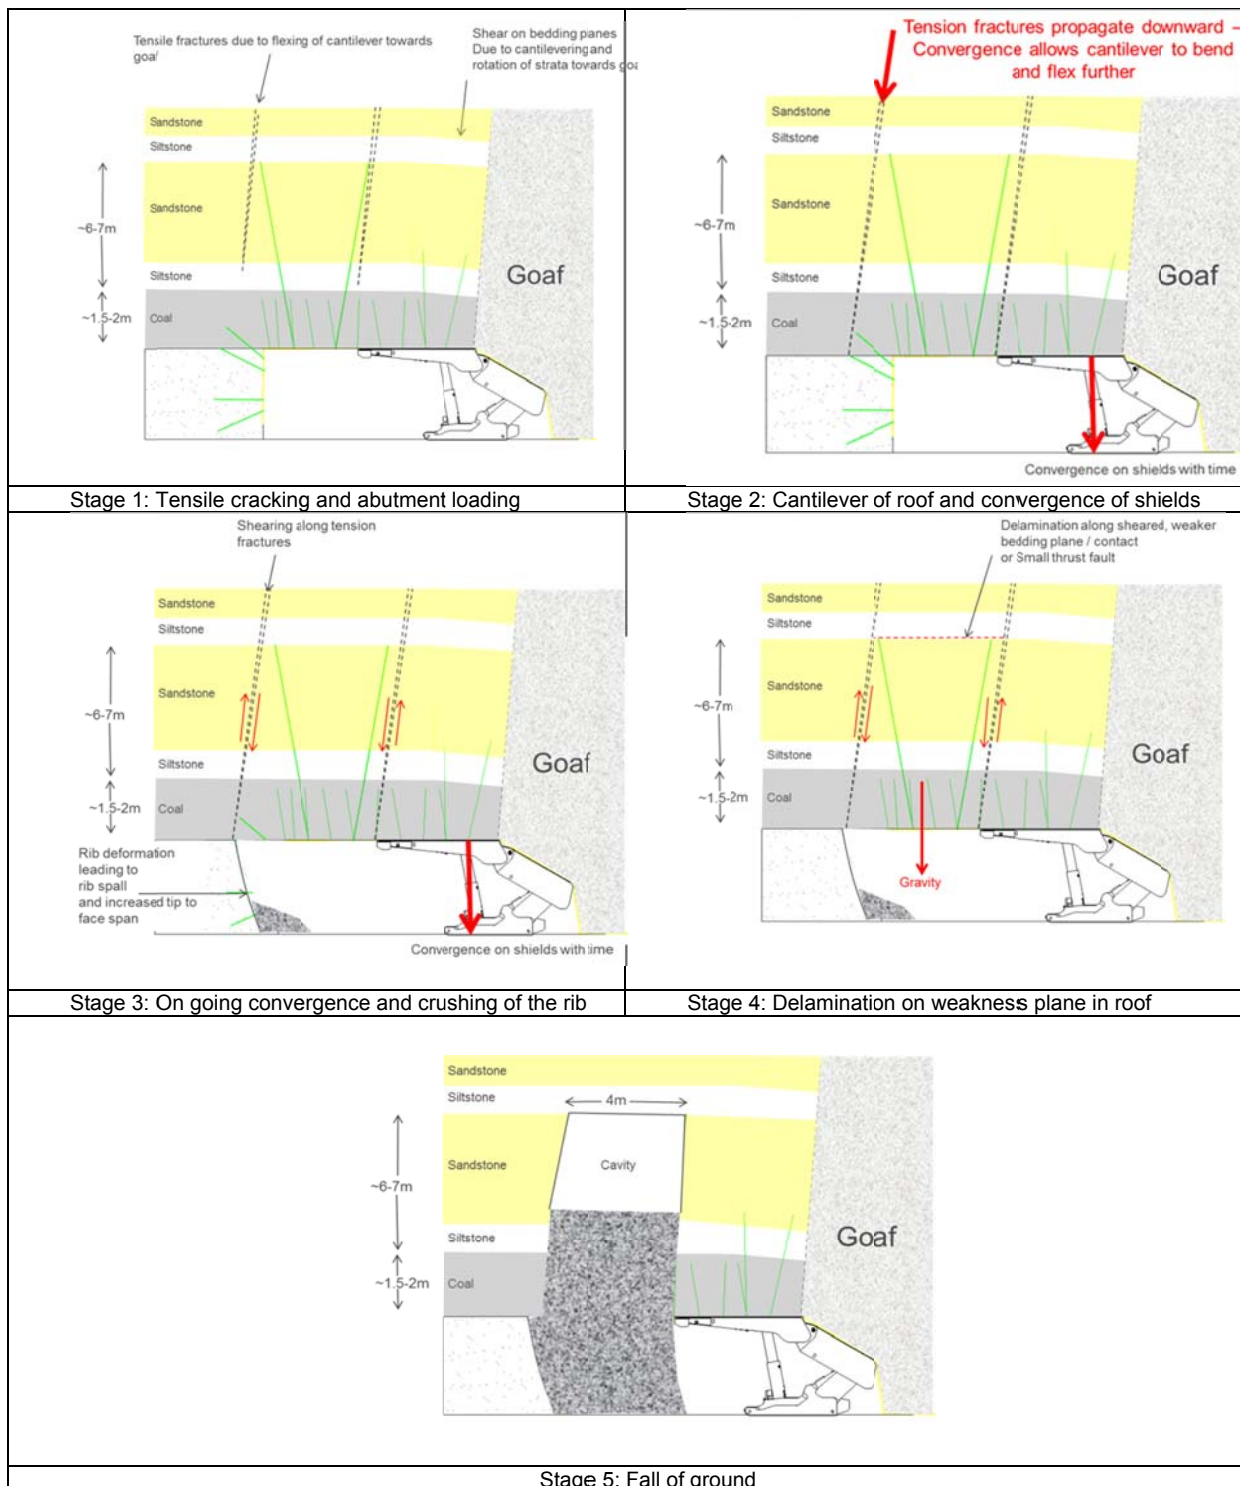
A simple representation of the fall mechanism is depicted in the illustration below (Figure 8), where the mechanism described is very similar to that identified by Hill, D (2006) ACARP C13022.

Figure 8: Failure mechanism and failure stages

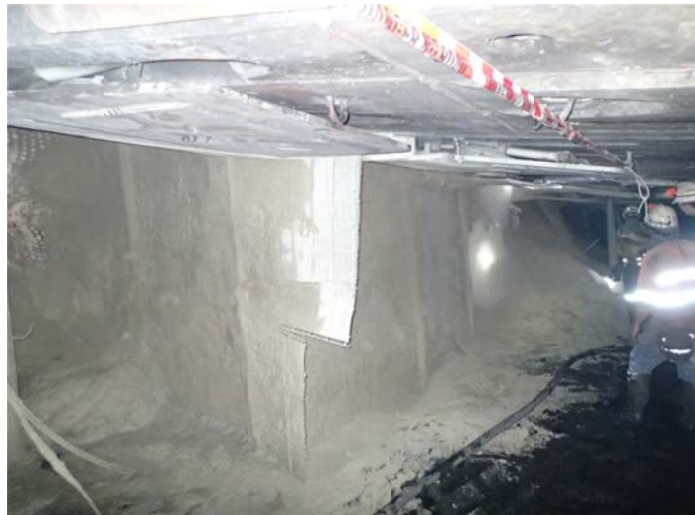
Figure 9: Shuttering off the fall material in preparation for consolidation of the muck pile and backfilling of the void in the roof

- 2) Shutter off the fall area in preparation for backfilling with a weak grout mix. Drill proving holes and install stand pipes to ensure the grout fills the cavity above the fall (Figure 9).
- 3) Pump a weak cement fill material from the ground up, in stages to fill the void and consolidate the fall material.
- 4) Re-mine and re-support the tip to face zone from the MG side of the fall to the E-frame, using a road header – ensuring the excavated profile is fit for purpose for the resumption of shield salvage.
- 5) Resume salvage operations.

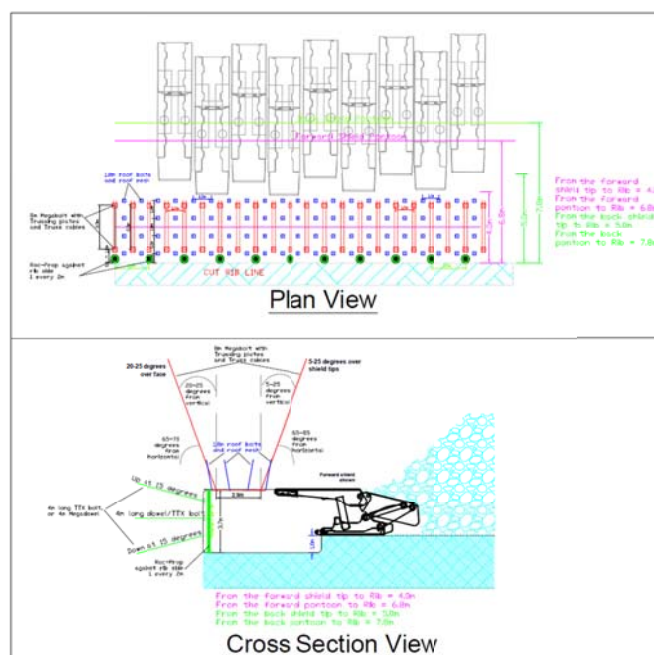
Figure 10: Support plan for re-mining through consolidated muck pile

The outcome was to re-mine and re-support the fall material using roof bolts and truss cables - this being the technically preferable option which had the least risk in terms of potential injury during installation as well as providing a higher actual support capacity. In addition, the installation of bolts and cables provided the best end result when salvage operations resumed. Steel sets would inherently be exposed to significant damage during the recovery of shields, where their structural integrity could come into

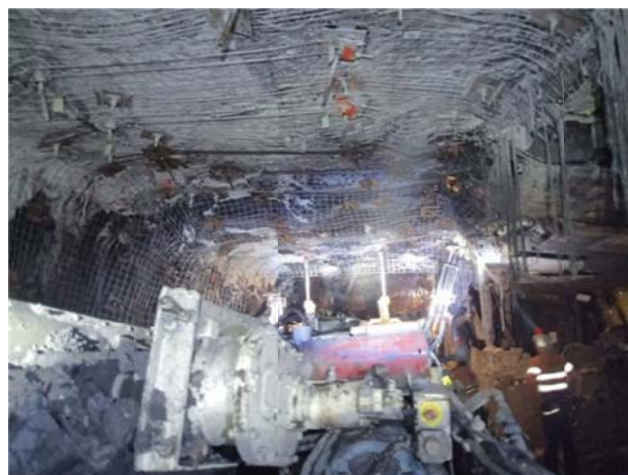
Figure 11: Roadheader re-mining through the consolidated muck pile under the backfilled void

Once the method was finalised and the excavation geometry and support plans were issued, the roadheader began mining through the shutter. Re-mining took place from the 20th January and had completed mining onto the E-frame on 16th February, including the recovery of Shield 76 from within the consolidated muck pile. Figures 11 to 14 illustrate the re-mining process.

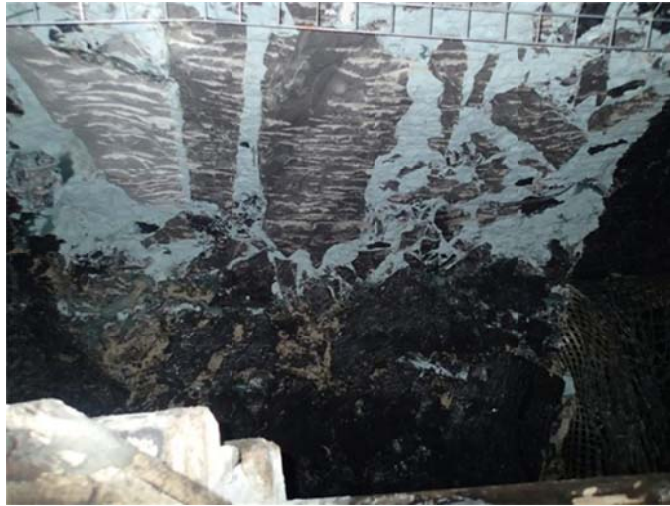
The drilling confirmed that the muck pile was sufficiently consolidated and that the voids within the shutter and above the roof-line were filled. In addition, results showed that the rock mass above both the canopies and over the block was competent.

Figure 12: Consolidated muck pile and grout filled voids

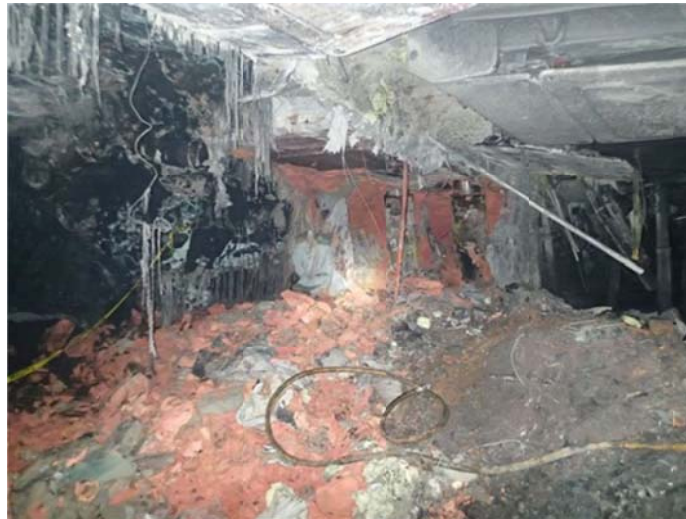
Figure 13: Recovery of shield 76 from within the consolidated muck pile
